# Chapter I: Purpose and Need

The National Park Service (NPS) is considering the rehabilitation, restoration, and resurfacing of the Yosemite Valley Loop Road within Yosemite Valley, Yosemite National Park, California (figure I-1). Maintenance repairs have not been made on the roadway and associated drainage facilities for many years, and visitor safety is a growing concern along this heavily-used travel corridor.

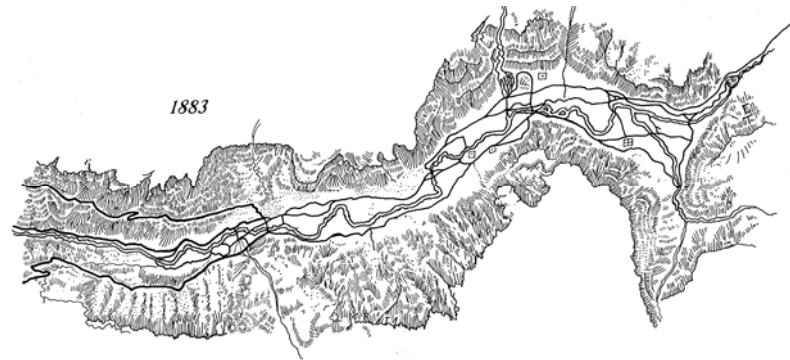
**Figure I-2.** Yosemite Valley Roads, 1883.

The Yosemite Valley Loop Road is a historic feature in Yosemite National Park, dating back to the 1870s. First built as a stage coach road in 1872, the Yosemite Valley Loop Road has seen several iterations over its long history. The Grand Carriage Drive around Yosemite Valley was completed in 1882 (figure I-2), marking the creation of a loop road traversing the northern and southern boundaries of the Valley (Greene 1987). Two years later, the first real funding for Valley roads was secured, at which time \$25,000 was appropriated to purchase, construct, and complete avenues, roads, trails, walks, and bridges in Yosemite Valley. The road was originally paved in 1909, and culverts were first installed a year later beneath stretches of Southside Drive.

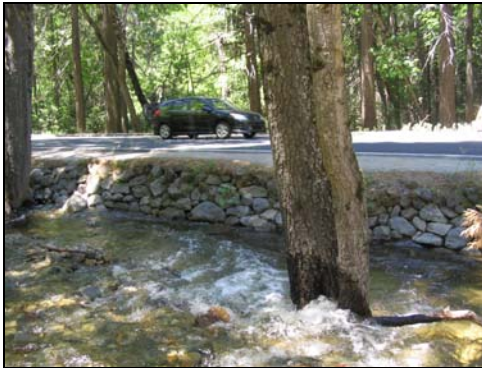
Seasonal flooding  
at Bridalveil Creek  
drainage

**Figure I-3.** Examples of existing roadway and drainage conditions along the Yosemite Valley Loop Road near El Capitan Straight and Bridalveil Straight, Yosemite National Park, California. (NPS Photos)

The need for this project is evidenced by the fact that the existing road surface and associated drainage features are in poor condition because major maintenance repairs have not been undertaken for many years. Numerous existing culverts are undersized, in disrepair, and/or ineffectively located to capture peak seasonal run-off (figure I-3). In addition, informal roadside parking at some locations along the Yosemite Valley Loop Road presents visitor safety and resource impact concerns.

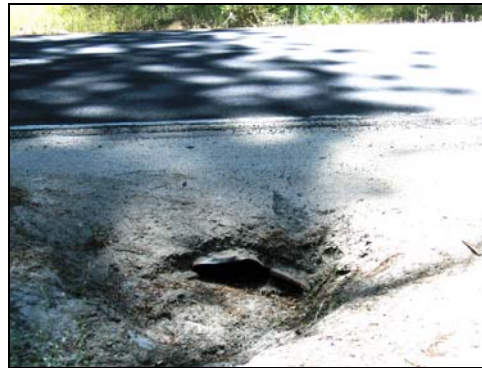
Dysfunctional  
culvert at El  
Capitan Straight

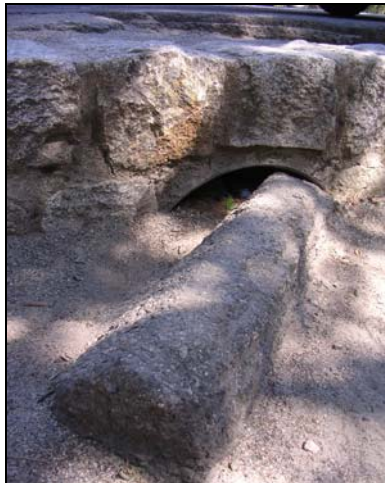
Dysfunctional  
culvert at  
Bridalveil  
Straight

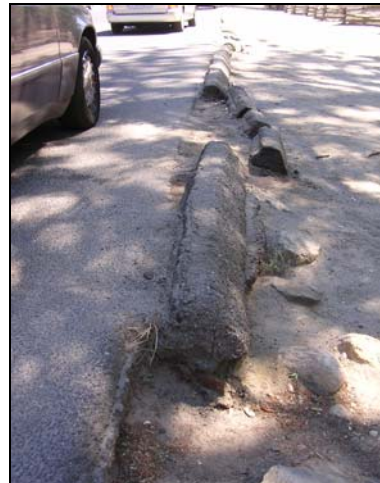
Degraded  
curbing at  
Bridalveil  
Straight
